Institute for Public Service Seattle University Spring 2011

Table of Contents

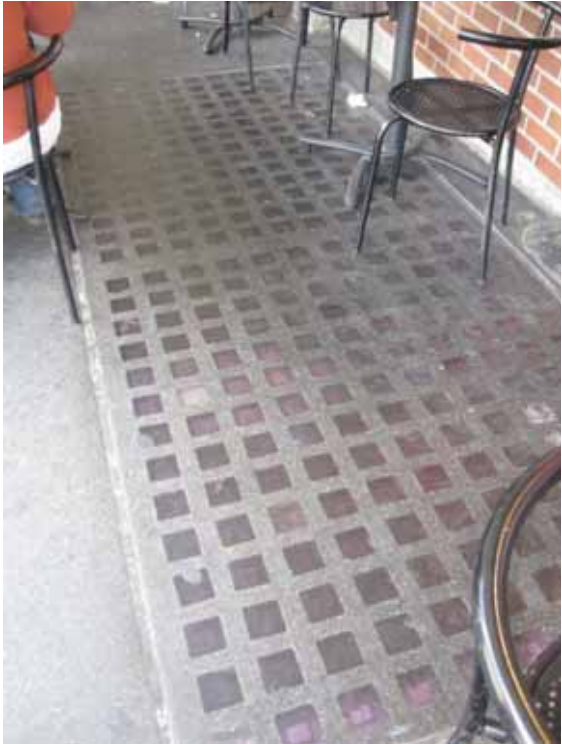
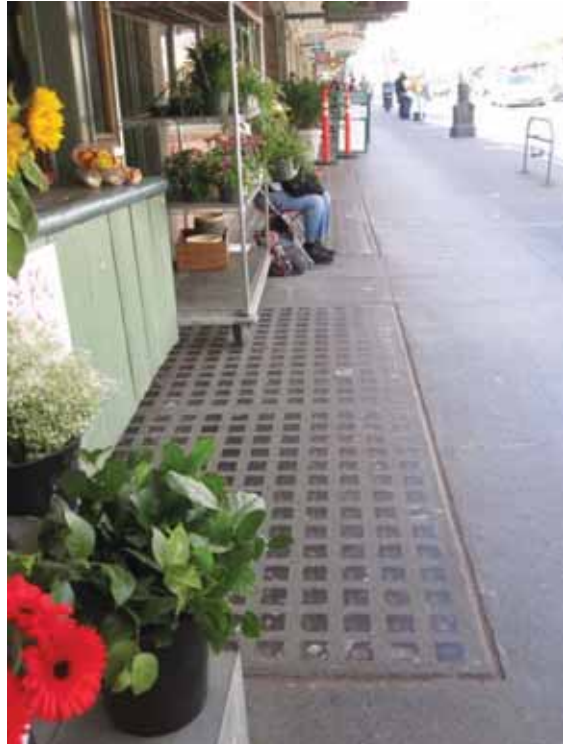
Cross Streets: Pike Street & Union Street

General Location: Pike Place Market

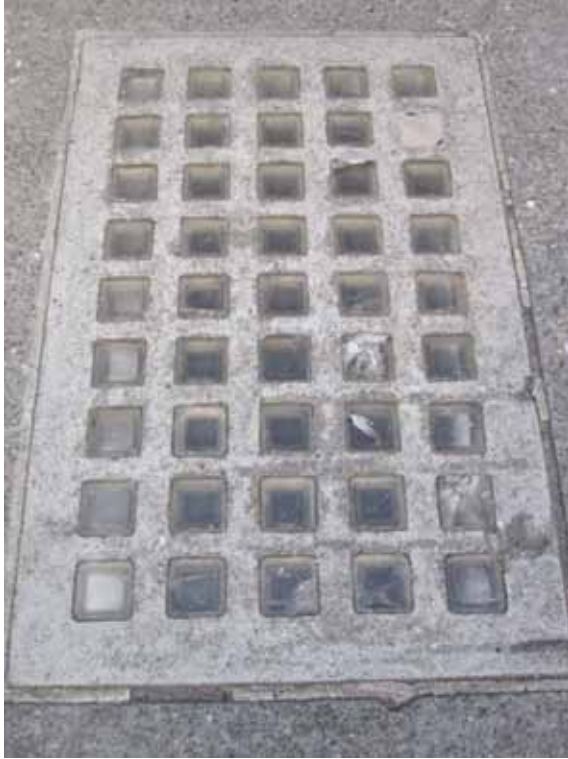
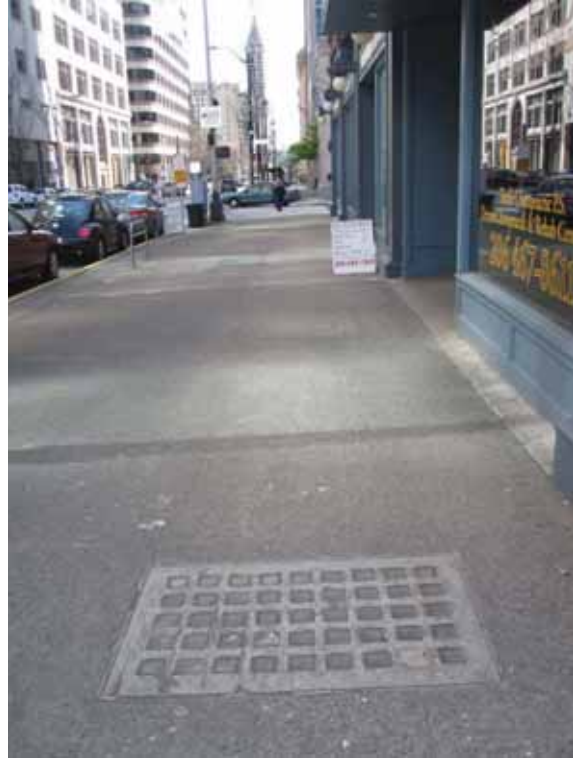
Cross Streets: University Street & Seneca Street

Comments and Conditions: This sidewalk's areaway consists of 1 panel of clear glass prism lights.

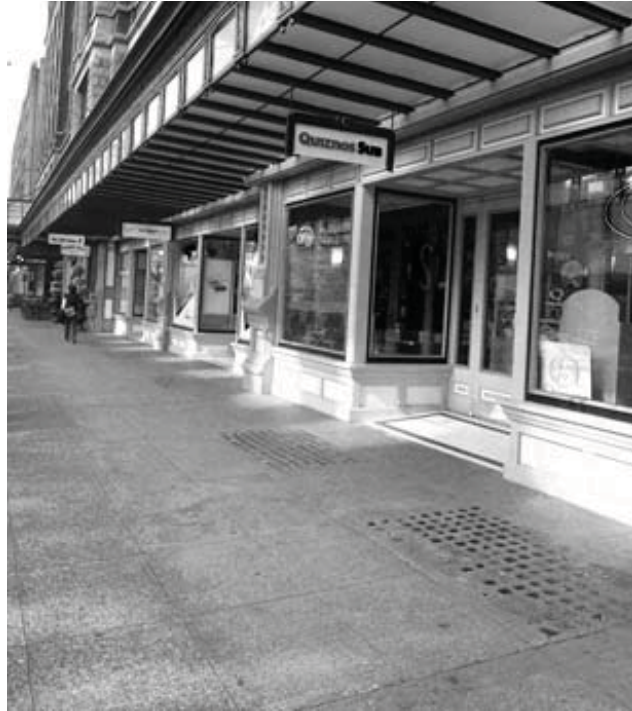
Cross Streets: Marion Street and Columbia Street

Comments and Conditions: This areaway does not currently have a designated number and was assigned a temporary number for the purpose of identification. This areaway extends for an entire block on the western side of 1st Avenue west. There are 19 panels of prism lights, two of which are manhole covers. Two area businesses have seating areas over the prism lights. Panels of lights in the entrance of popular businesses are especially worn. The condition of the concrete is fair overall.
